DOCUMENT NO: TT-CATPLUS-20-002  
 REVISION: 01

**TITLE: USB/FIBER CONNECT ORDER FOR CATALYST+**

<b>Instrument/Model:</b>	CatalystPlus/CatalystPlusHD		
<b>Initiator:</b>	Michael Götz	<b>Date:</b>	28.12.2020
<b>TT Completion Status:</b>	<input type="checkbox"/> Incorporated into Service and/or Training Manual: Manual Document Number: _____ Manual Revision: _____  <input type="checkbox"/> The Service Bulletin is Obsolete <input type="checkbox"/> Other, Explain:		
<b>Systems Affected:</b>	<input checked="" type="checkbox"/> All System in the field <input type="checkbox"/> Selected Systems <input type="checkbox"/> Affected S/N list attached <input type="checkbox"/> None		
<b>Status / Priority</b>	<input type="checkbox"/> Immediate (Open/Schedule Call) <input type="checkbox"/> Perform Next Visit <input checked="" type="checkbox"/> Procedural/Informational (No action needed)

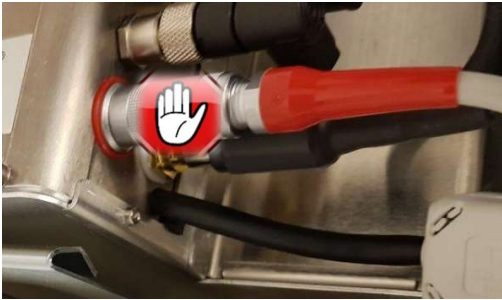
**Picture 1**

After installing the Catalyst+/Catalyst+HD hardware, do NOT (Picture 1) install the Vialux Power Supply so that the Vialux hardware will not be powered. Connect all fiber cables and power connection to the PM and USB extenders. Add the power button and power up the system.

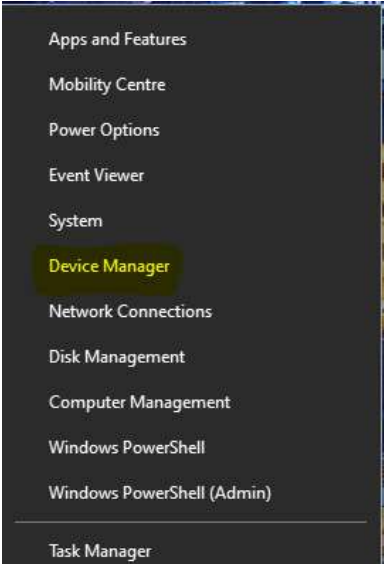
**Picture 2**

Start the Catalyst+(HD) client computer and open the device manager by right click on the windows flag lower left corner and choose “Device Manager” (Picture 2). At the Device Manager scroll down and fold out the Universal Serial Bus devices (Picture 3)

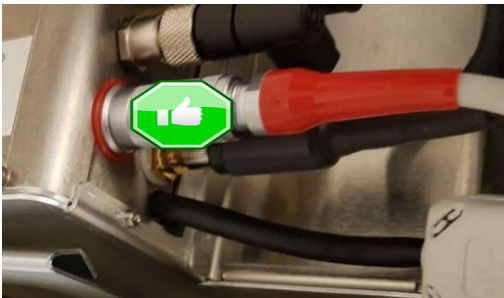
Picture 6

When all PM-Boxes of your system shown in the device manager of the client computer you can connect the not connected USB 3.1 extender to the Asmedia card of the client computer. Add power to the DLS scanner hardware (Picture 6) and check with the Service Tool the status of the PM-Box(es), DLS-Scanner(s) and synchronization (Picture7).

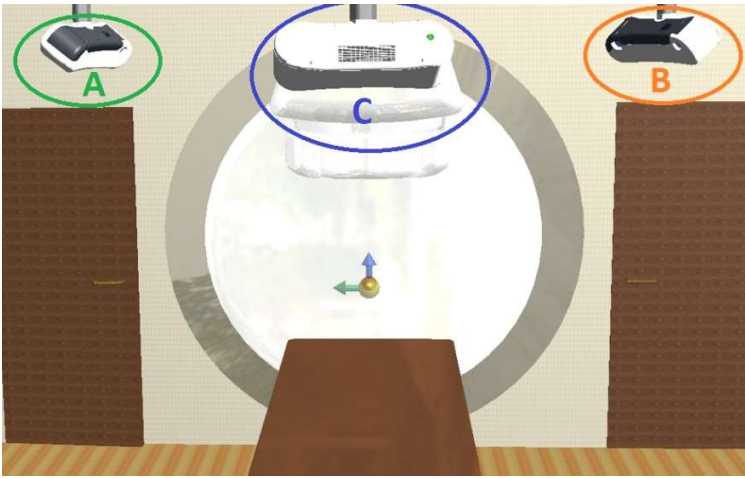
Best Practice is to name all fiber cables from Catalyst+(HD) and mark them at all to be installed systems Identical for all fibers, fiber extender and extender itself :

- Front View:
- Left DLS-Scanner = A1
  - Left PM-Box = A2
  - Right DLS-Scanner = B1
  - Right PM-Box = B2
  - Master DLS Scanner = C1
  - Master PM-Box = C2
